Membrane and Flashing Condition Indexes for Modified Bitumen Roofs

Inspection and Distress Manual

David M. Bailey

March 2010

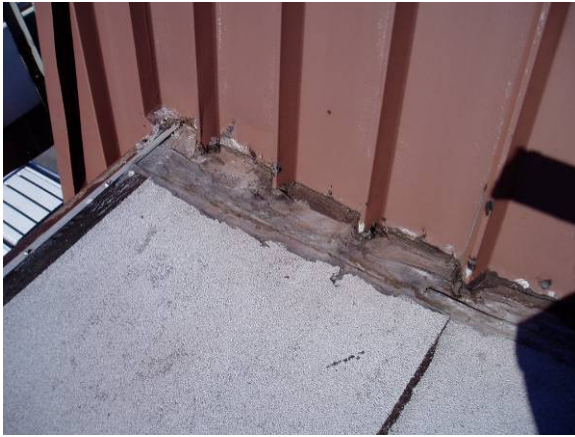
BF-H-4: No base flashing is present.

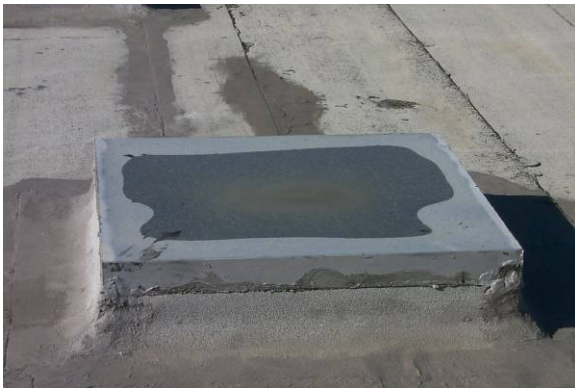
MC-L-2: Metal coping cap is deformed and allows water to pond on the top.

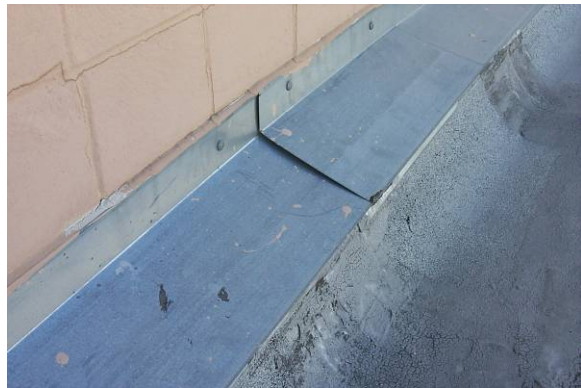
MC-M-2: Metal coping cap has loose fasteners, failure of soldered or sealed joints, open joints, or loss of attachment.

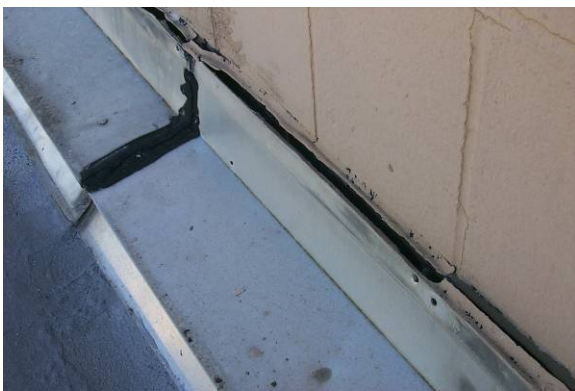
MC-M-3: Sealant at reglet or top of counterflashing is missing or no longer functioning, allowing water to channel behind.

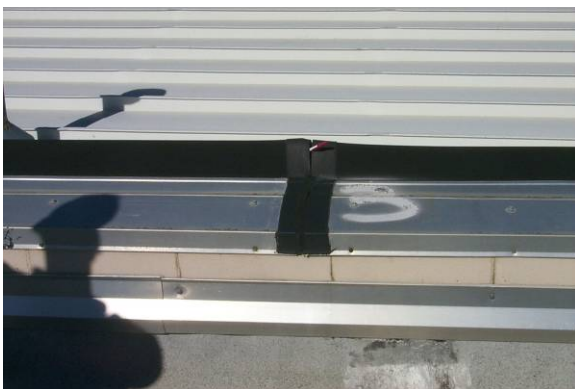
MC-H-2: Corrosion holes penetrating metal on horizontal surface or rubber bellows of an expansion joint cover.

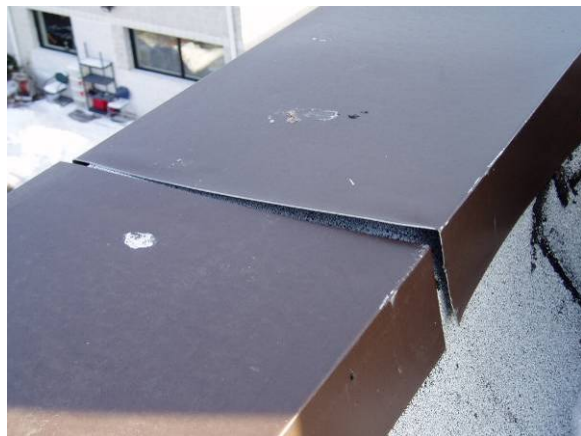
MC-H-3: Metal coping cap has missing joint covers where joint covers were originally installed.

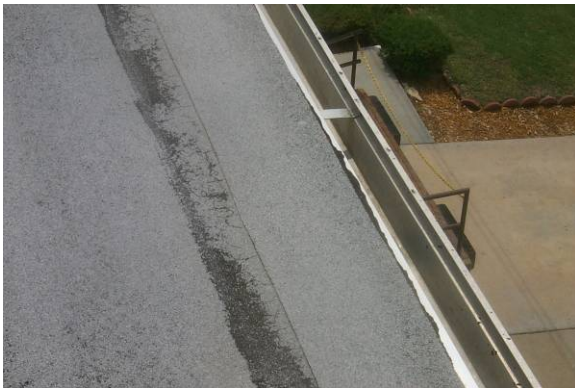
EM-L-1: The entire length of embedded edge metal flashings is rated low severity at minimum due to the maintenance problems.

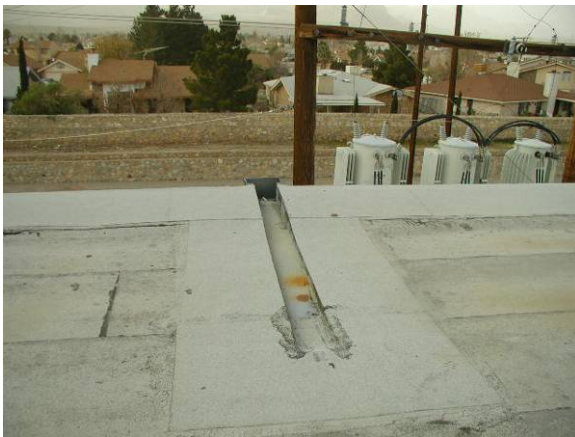
EM-M-6: Entire length of interior gutter is rated medium severity at minimum due to the maintenance problems.

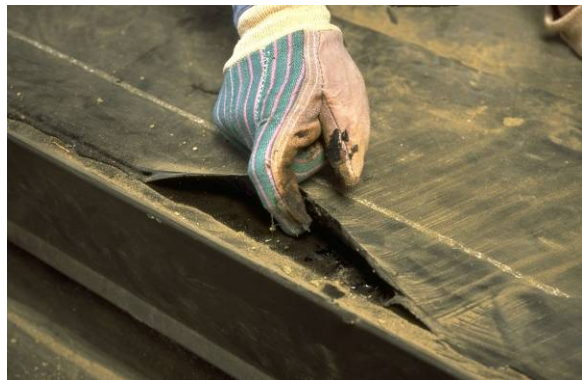
EM-H-1: Surfacing plies are missing or loose.

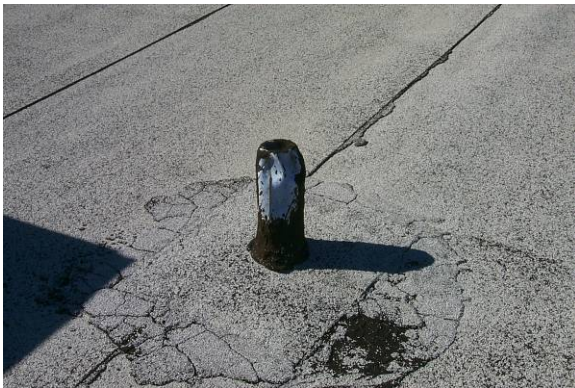
FP-L-1: Flashing sleeve is deformed.

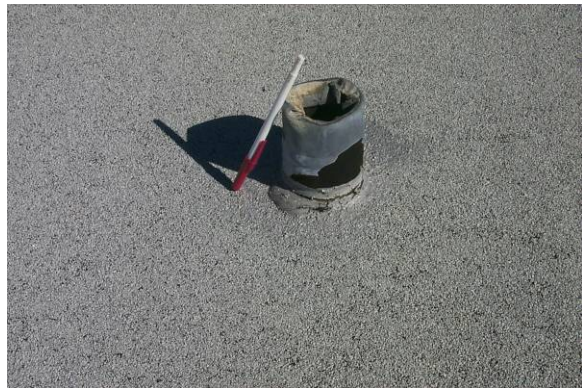
FP-L-2: Opening in the penetration or flashing is less than 6 in. above the roof surface.

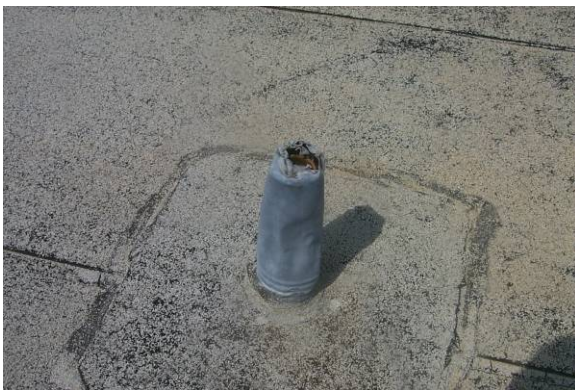
FP-M-2: Top of flashing sleeve is not sealed or has not been rolled down into an existing plumbing vent stack.

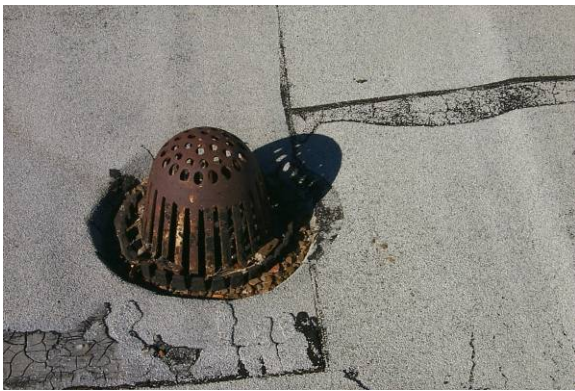
DR-M-4: Field seam exists under clamping ring.

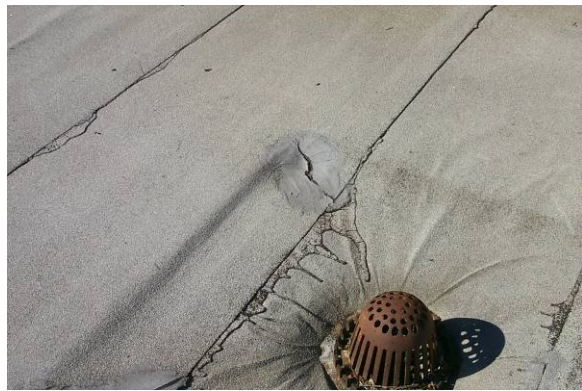
DR-H-1: Holes, splits, or tears in stripping ply caused by deterioration or physical damage.

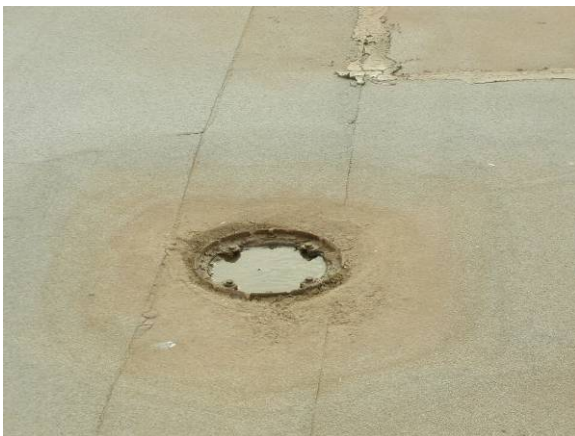
DR-H-3: Drain is clogged.

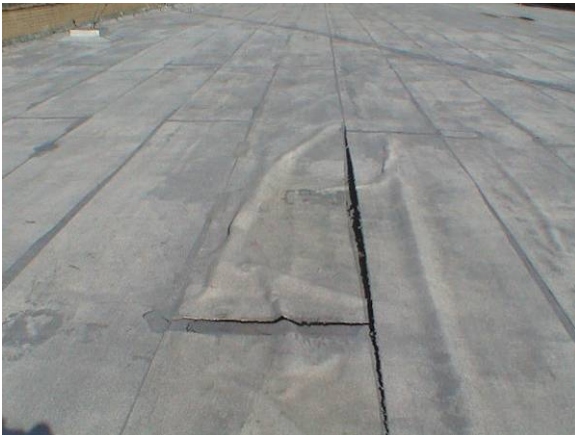
BL-M-2: Blister is beneath a seam, which has exposed unsurfaced membrane along the seam.

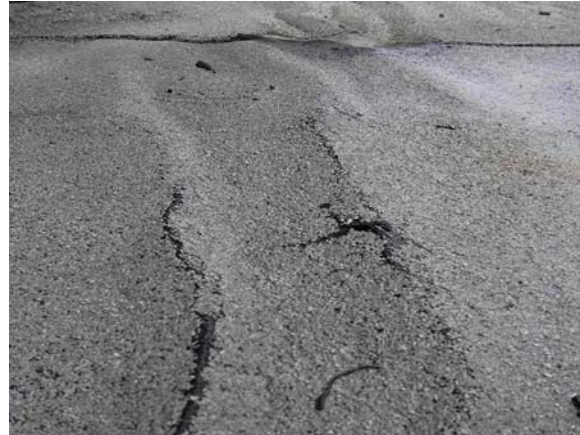
BL-H-1: The blisters are broken; there are holes, splits or tears.

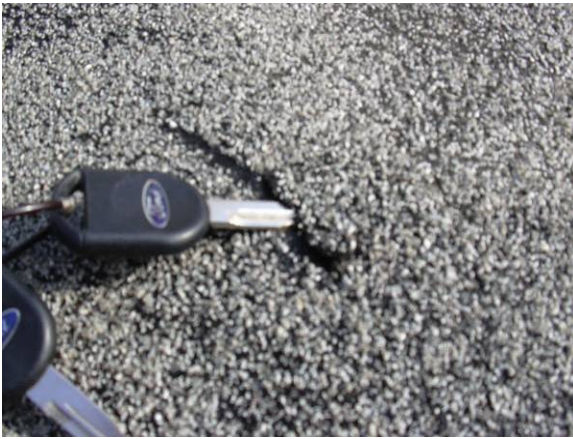
HL-H-1: All holes are considered high severity due to their high leak potential.

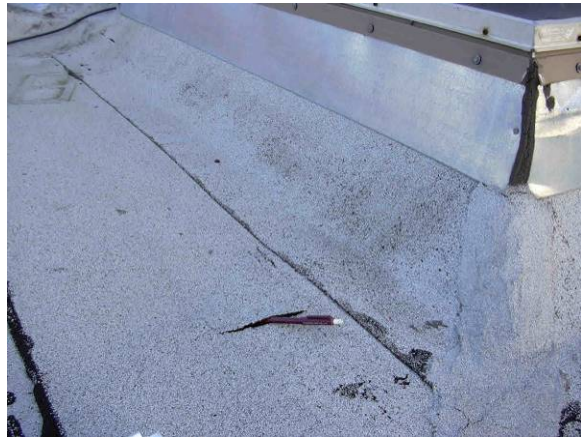
HL-H-1: All holes are considered high severity due to their high leak potential.

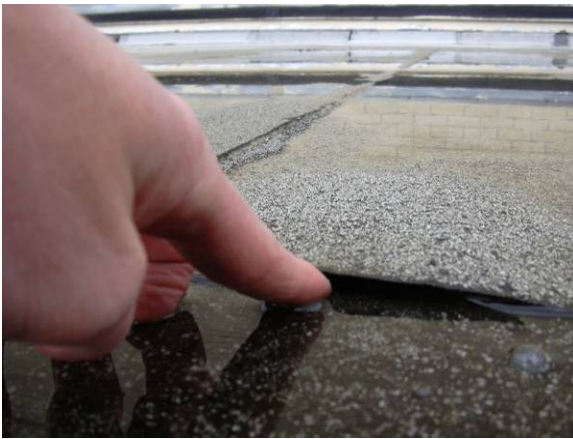
DS-L-1: Seam is open less than ½ inch.

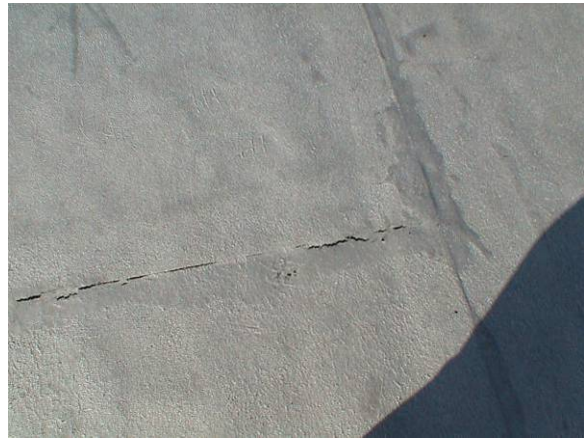
DS-L-1: Seam is open less than ½ inch.

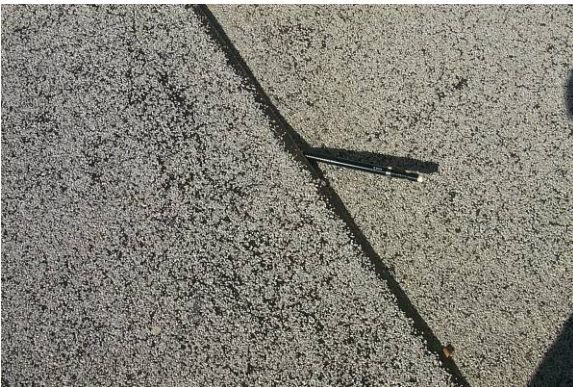
DS-M-1: Seam is open ½ inch or more, but does not allow water to penetrate the membrane.

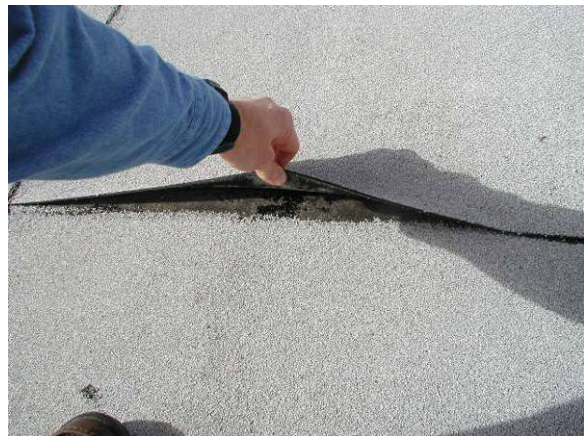
DS-H-1: Seam is open through its entire depth, allowing water to penetrate.

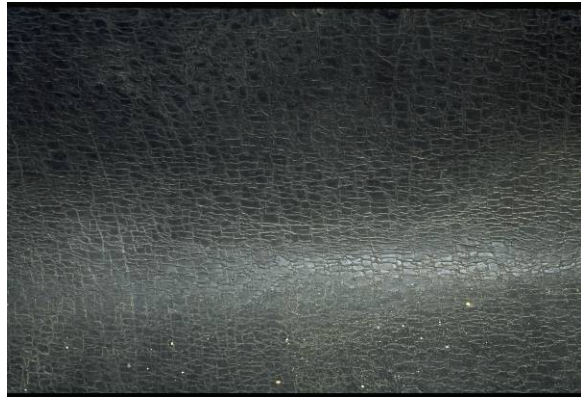
SR-L-3: On smooth liquid applied surfacing, there is evidence of crazing of top surface with hairline cracks (alligatoring).

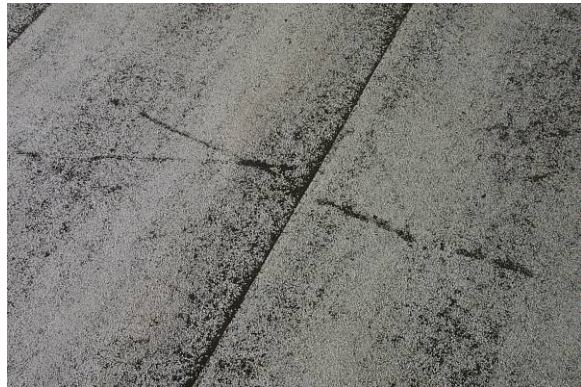
SR-M-2: On mineral surfaced capsheet surfacing, there is loss of granules, exposing the surfacing ply.

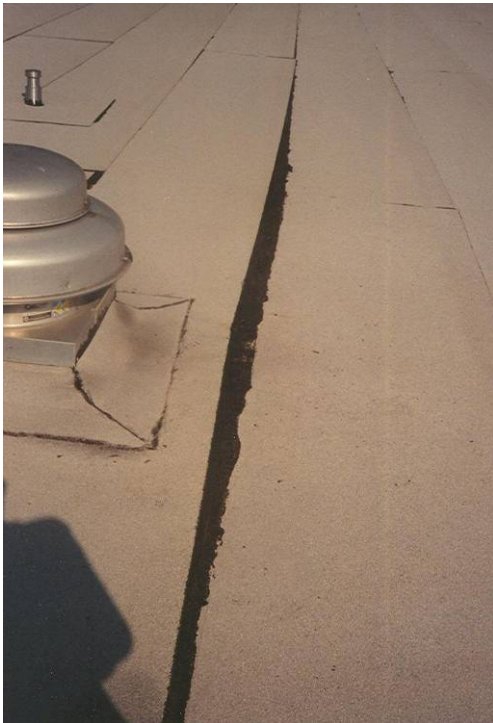
SL-H-1: More than 2 in. of slippage has occurred or the exposed bitumen has shown deterioration. There may be evidence of humping and wrinkling.

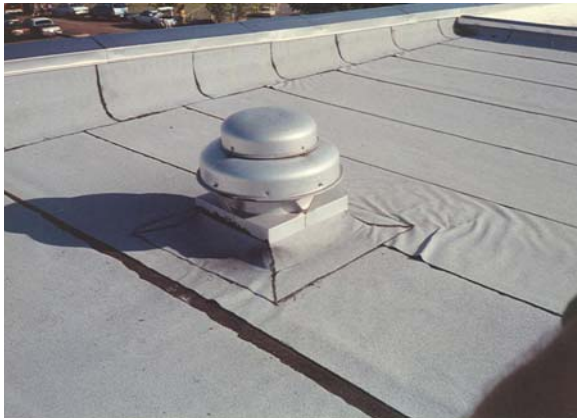
SL-H-1: More than 2 in. of slippage has occurred or the exposed bitumen has shown deterioration. There may be evidence of humping and wrinkling.

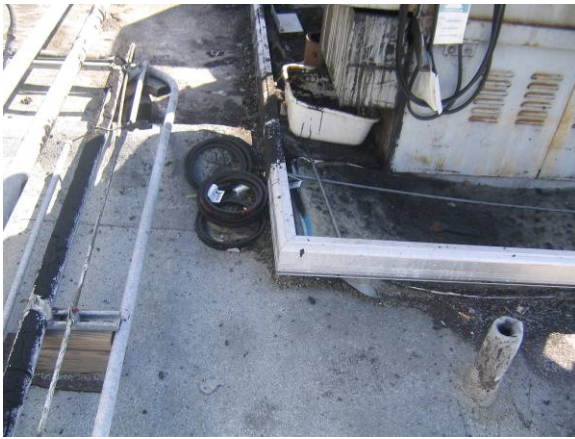
DV-M-1: The collection of foreign objects which are not removed from the roof during the inspection.

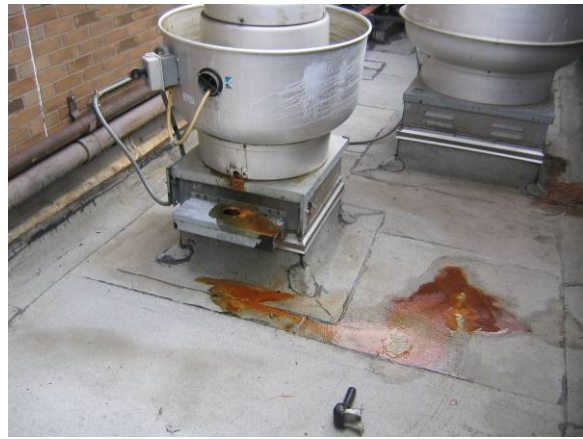
DV-M-2: Grease, solvent, or oil drippings on the roof which show no degradation of the roof membrane.

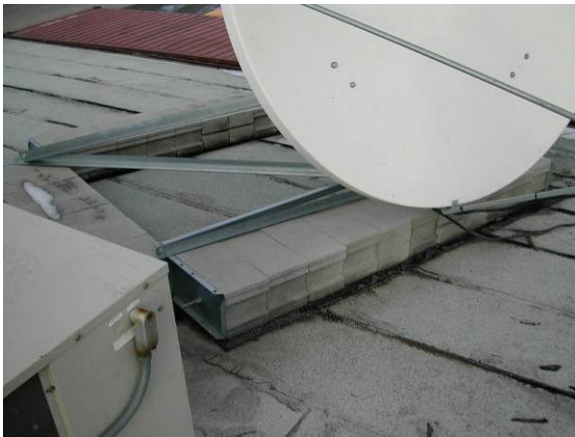
EQ-L-1: All improper equipment supports are rated low severity as a minimum due to the maintenance problems.

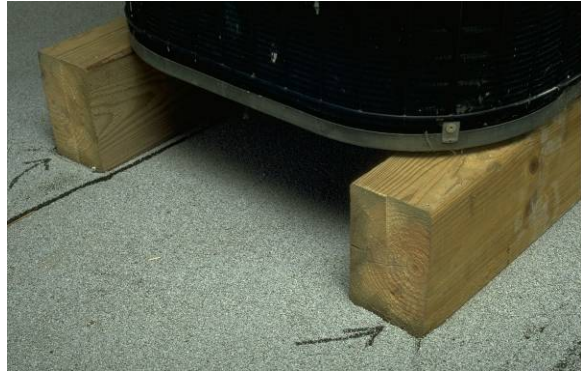
EQ-L-1: All improper equipment supports are rated low severity as a minimum due to the maintenance problems.

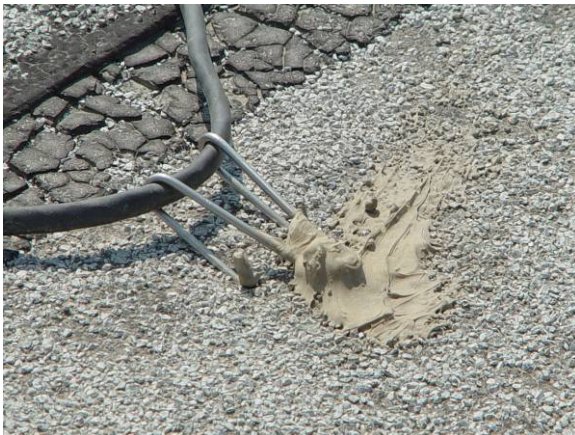
EQ-M-2: The equipment is bolted through the membrane but the bolts appear to be sealed.

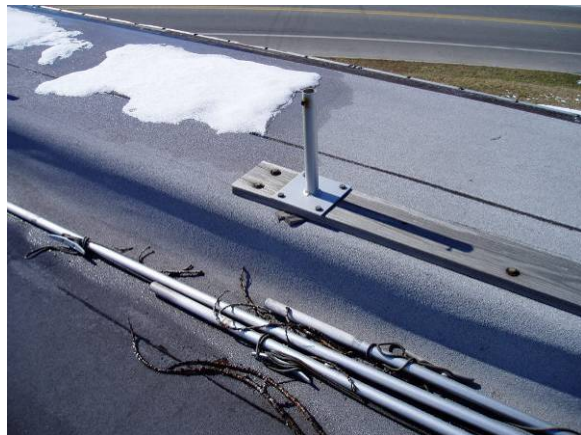
EQ-H-2: The equipment is bolted through the membrane and the bolts appear not to be sealed.

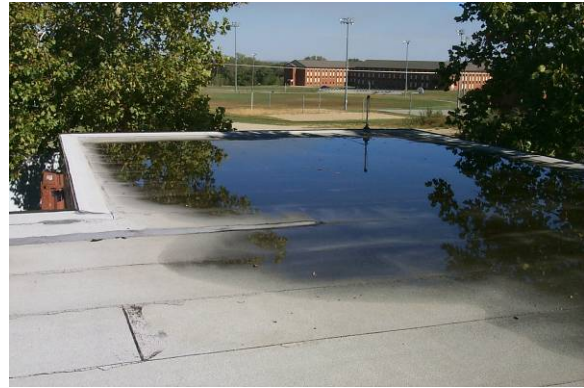
PD-L-1: Ponding is rated low severity due to the maintenance problems associated with it.
